Environmental Pollution in five floors (10th to 14th) Resulting From the use of Depleted Uranium Weaponry in the AL-Tahreer Tower Building

Hayder Ahmed Hasaan
Mazen Abbas Al-ghirrawy
Thamer M.Mohammed
Jaffer T.Abd Al-Hussein
Ministry of science and Technology

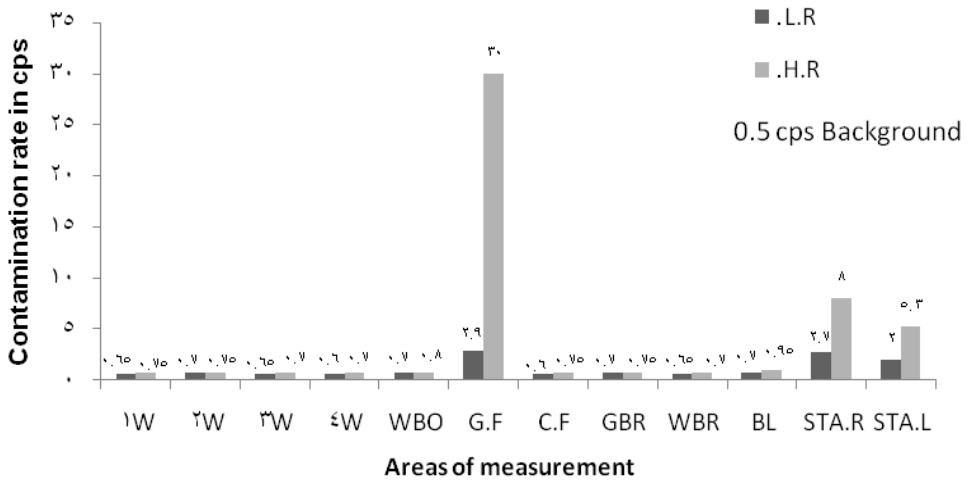
Figure (1) contamination rate in floor 10 before processes decontamination

The results of contamination rates measurement before decontamination processes indicates; the higher contamination rates were in ground and stairs in 10th floor as shown in figure(1), figure(2) show higher contamination rates were in ground and ceiling of 11th floor ,while in 12th floor the higher contamination rates were existent in wall1 ,wall2 ,ground floor , ceiling ,and stairs as shown in figure(3). Figures (4, 5) show there is no contamination in floors 13th and 14th .Exposure rate measurements were performed before the decontamination processes. Figures (6, 7, 8, 9 and 10) show that.

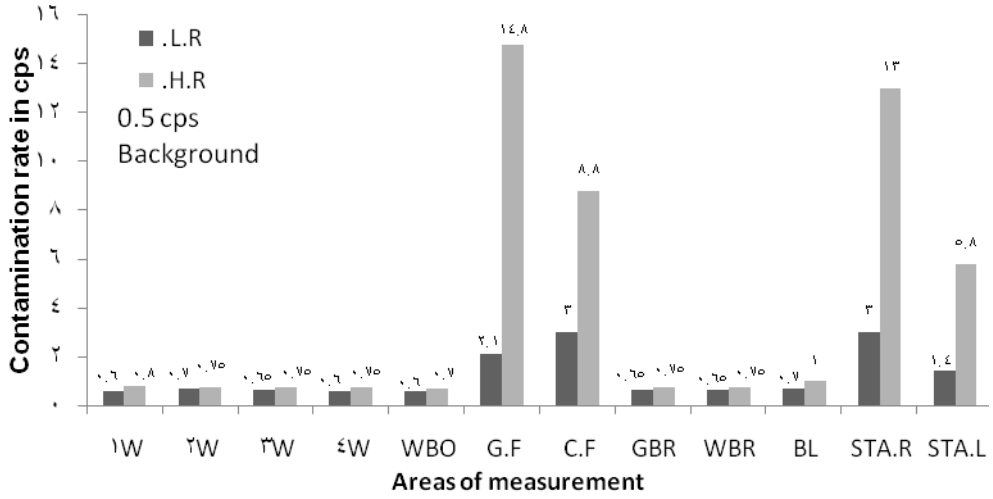
Figure (2) contamination rate in floor 11 before processes decontamination

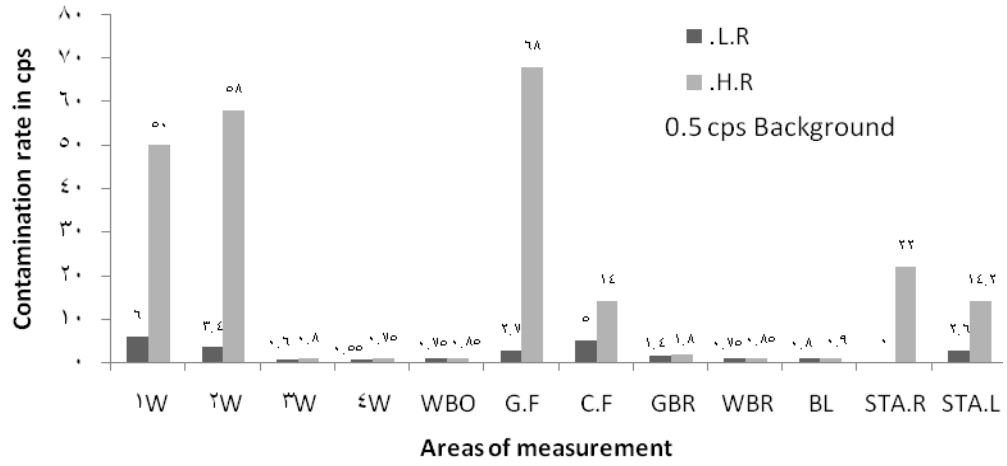
Figure (3) contamination rate in floor 12 before processes decontamination

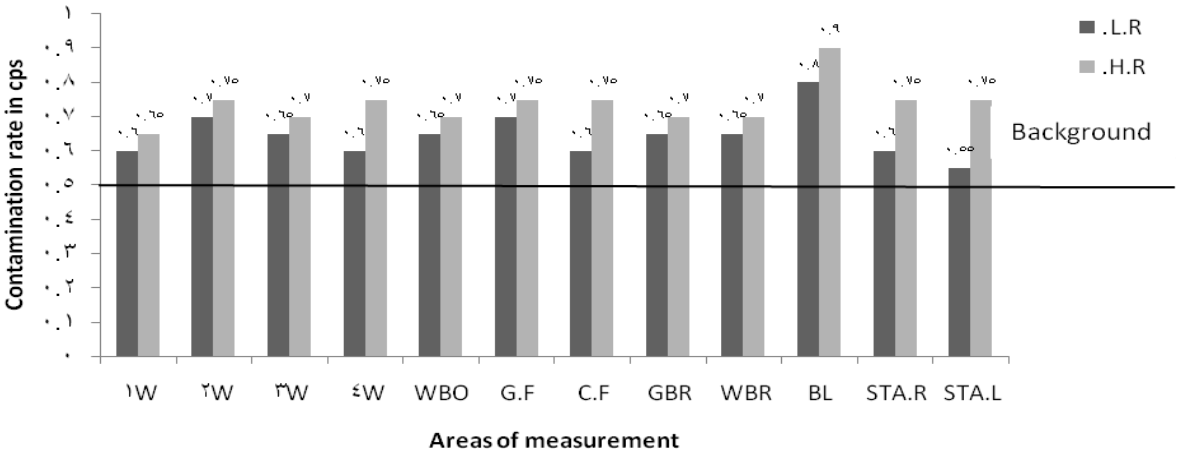
Figure (4) contamination rate in floor 13 before processes decontamination

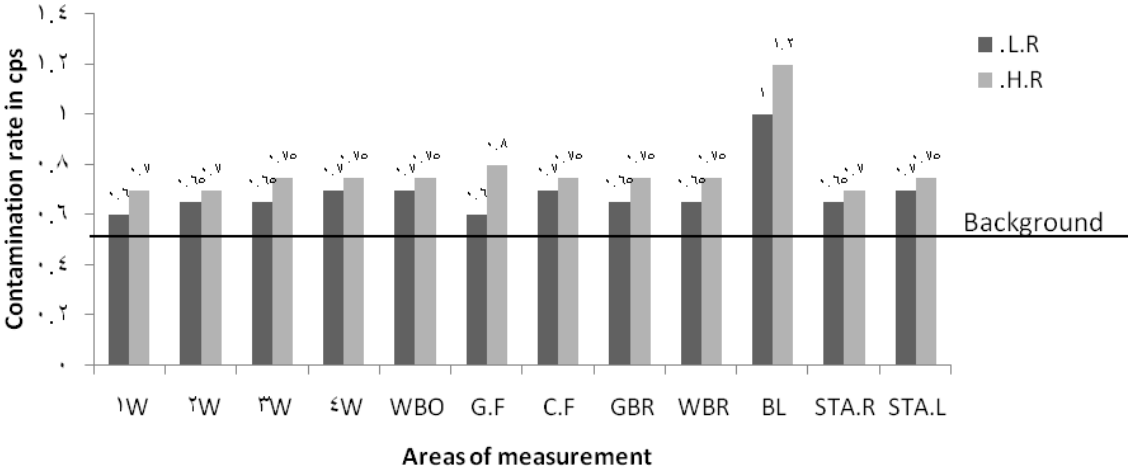
Figure (5) contamination rate in floor 14 before processes decontamination

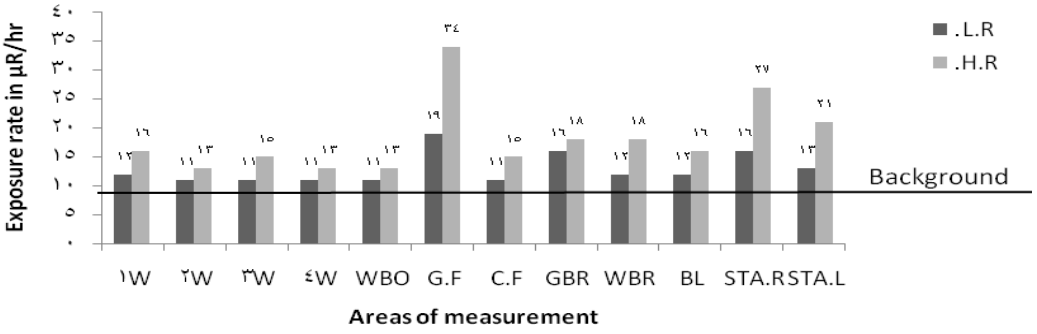
Figure (6) Exposure rate in floor 10 before the decontamination processes

The results of exposure rates measurement before decontamination processes indicates; the higher exposure rates were in ground of floors (10th,11th, 12th), ceiling, and stairs in floors (11thand 12th).The above figures indicate the large spread of contamination because some materials have been transported from the building to other areas without taking any environmental consideration, in addition to the building subject to movement of the winds. Figures (11, 12) show the results of radiological survey in all floors which indicates the higher doses and contamination rates in 12th floor because the floor exposed to direct hits by depleted uranium bullets.

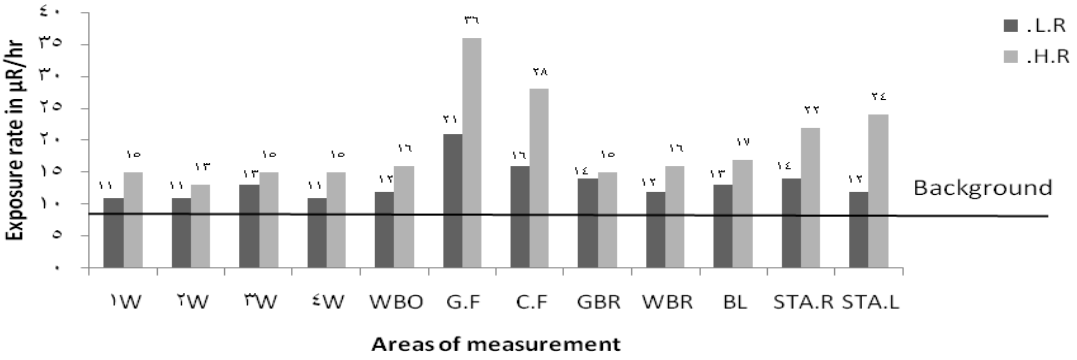
Figure (7) Exposure rate in floor 11 before the decontamination processes

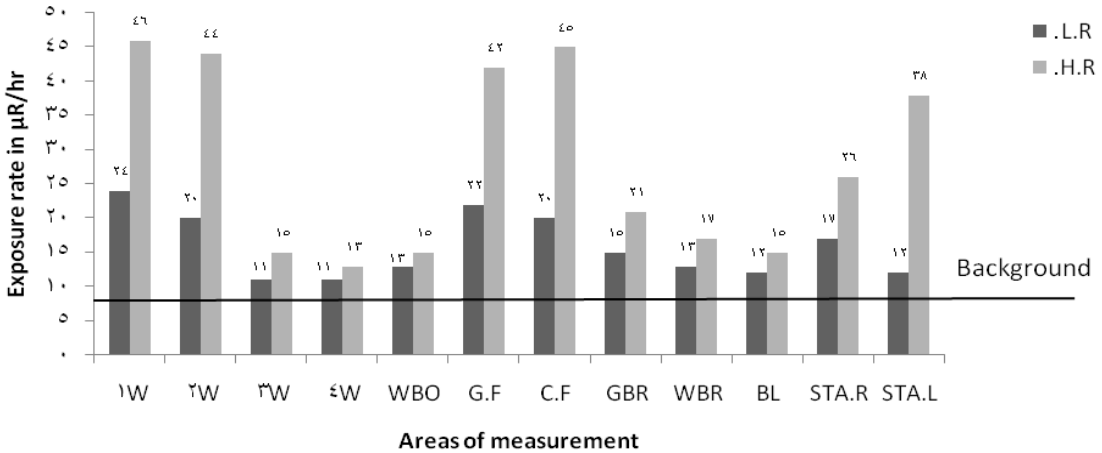
Figure (8) Exposure rate in floor 12 before the decontamination processes

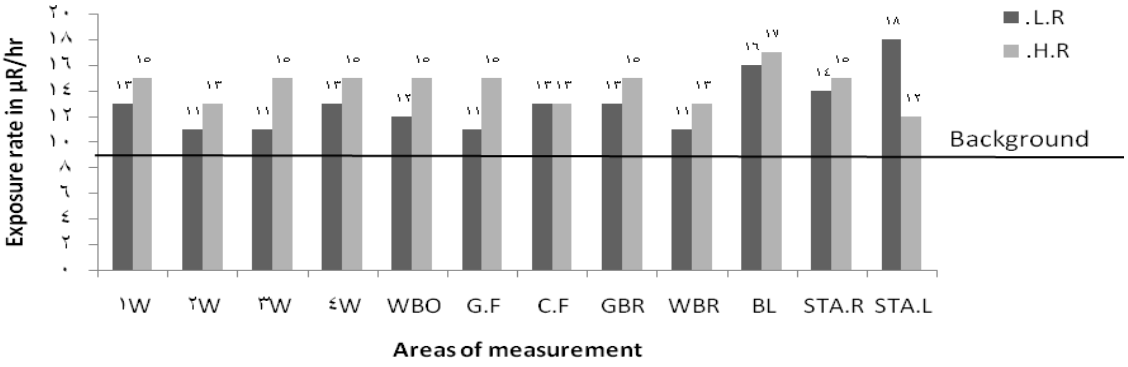
Figure (9) Exposure rate in floor 13 before the decontamination processes

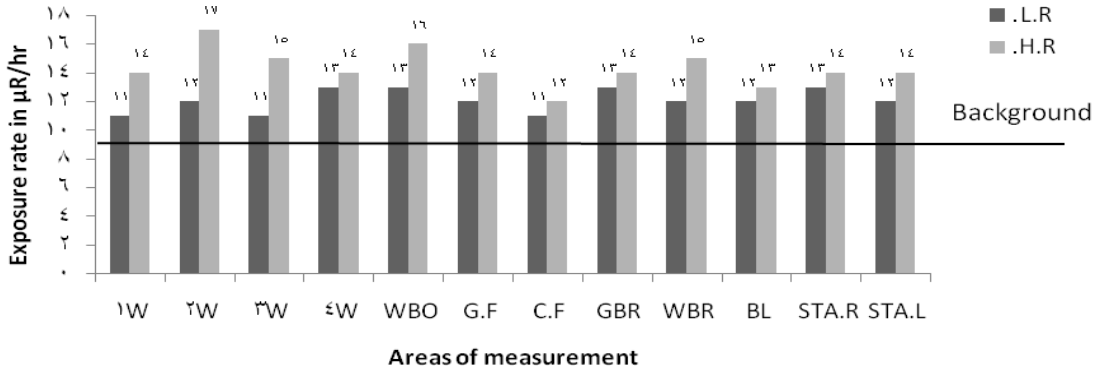
Figure (10) Exposure rate in floor 14 before the decontamination processes

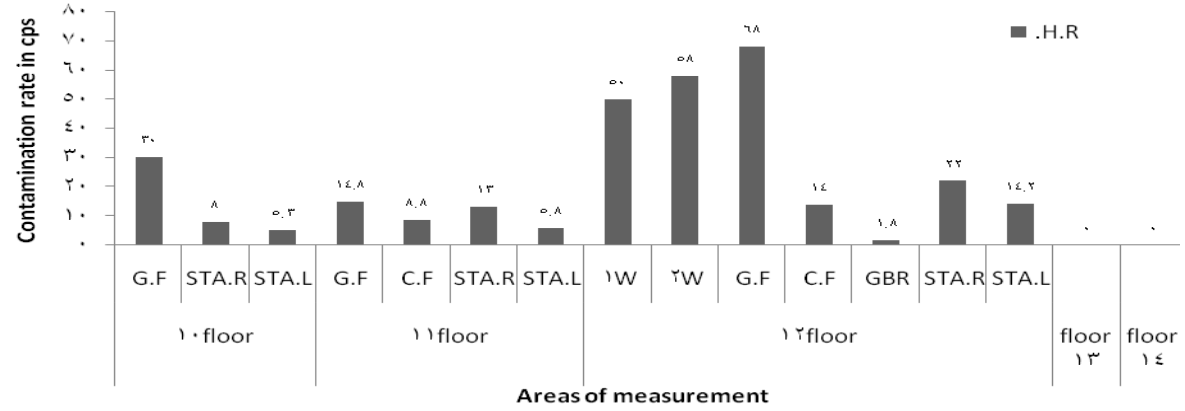
Figure (11) high value for contamination rate in all floors

Therefore, the work has been focused on decontamination processes and lifted the contaminated soil which is considered more than two times higher than the natural levels when were using the portable radiation detection equipments, and sometimes were used mechanical decontamination techniques involved the removal of some thickness of the material of construction of walls. The contaminated soil and waste collected in a special barrels intended for this purpose.

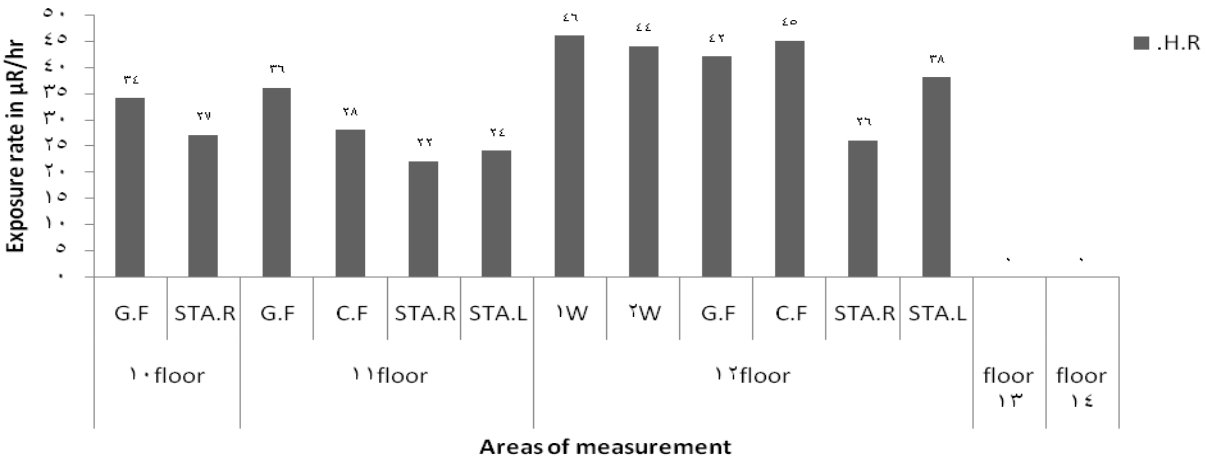
Figure (12) high value for exposure rate in all floors

3- The exposure rates especially near the contaminated regions are higher than the background level and within a range between 22 - 46 µR/h (figure 12), while the background level varies between (10-8) µR/h.
4- Samples of contaminated soil which were taken from floors indicated higher Pa-234m content, which ranged between (199.4-3179)Bq/kg figure (13) while, the natural background of this isotope is nil.

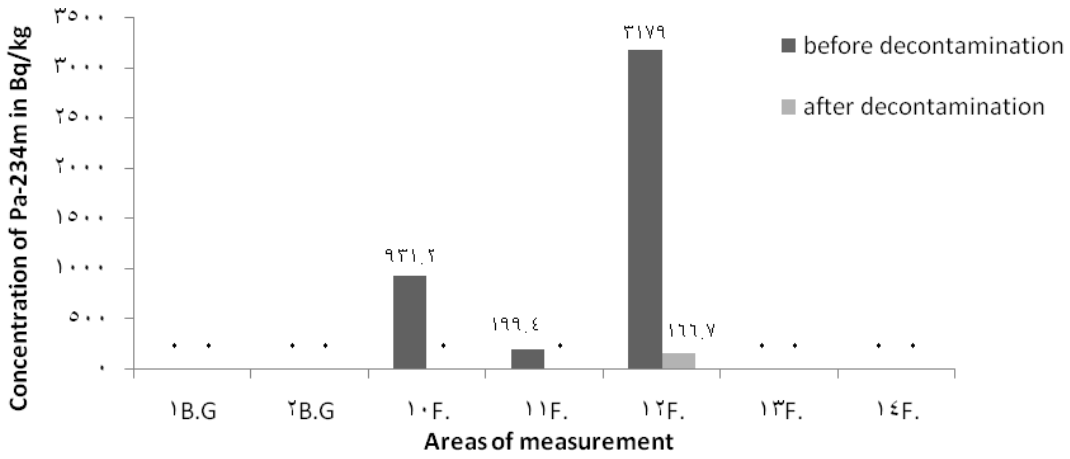
Figure (13) concentration of Pa-234m in soil sample before and after decontamination processes

This laboratory results can be consider normal and slightly higher in comparison with natural background level, and these concentrations of the radioactive isotopes can be considered within the regulations limits of the environment.

After the decontamination processes, soil samples were taken according to IAEA.The laboratory results indicated the presence of high concentrations of Th-234,and Pa-234m (an indicated nuclides for the presence of Uranium) of the soil samples in the floors (10 th,11 th and 12th) therefore we repeated the decontamination processes by putting detector (CAB) on distance 0.5 cm and with speed less than 10cm/sec on the soils in the floors [6] .Than the contaminated soil Collected in a special barrels intended for this purpose .Soil samples were taken and the results are shown in figures (13,14).

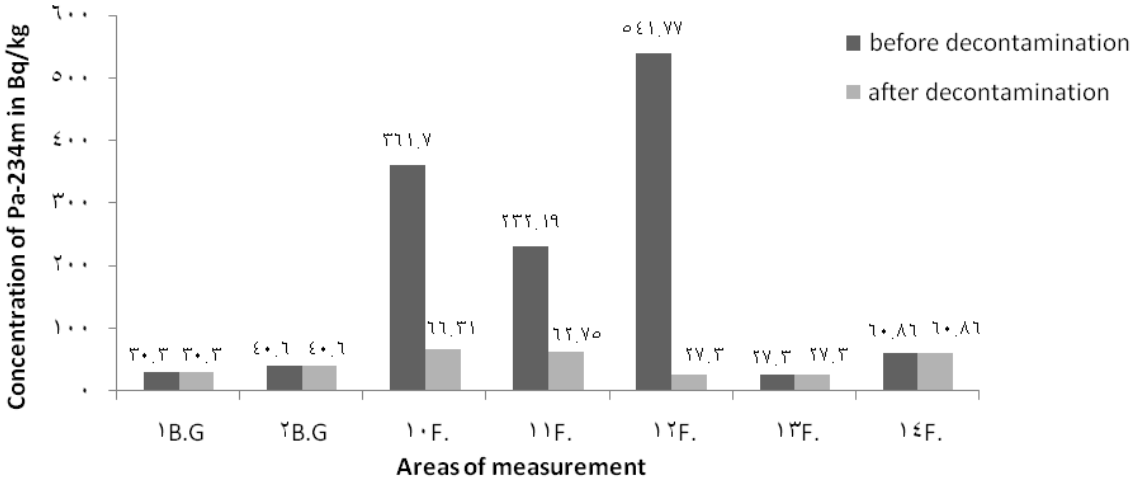
Figure (14) concentration of Th-234 in soil sample before and after decontamination processes
